Manhole Inspection Summary

Manhole # S31M__015MH

Insp Date: **12/26/08 11:24 AM**

Location Address: **610 Burgandy St**

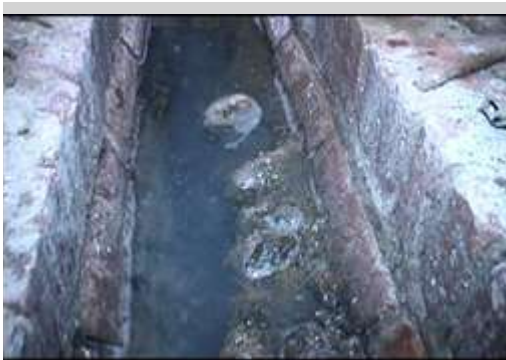
Miscellaneous

Condition: ☐ Sound ☐ Cracked ☐ Root Intrusion ☐ Deteriorated ☐ Leaks ☒ **Debris**

channel debris

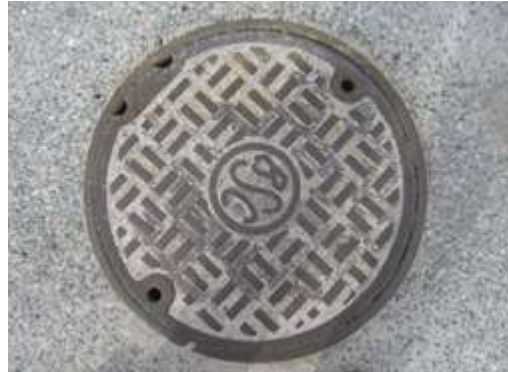
Miscellaneous

MH cover

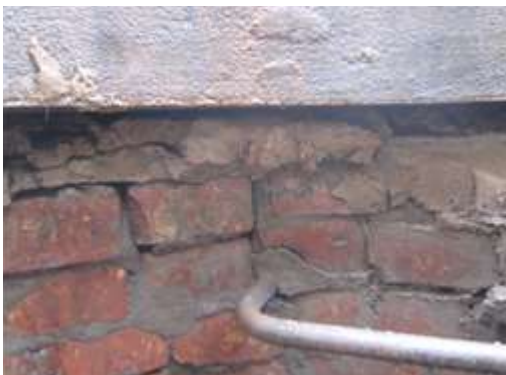
Defect 6

Condition: ☐ Sound ☐ Cracked ☐ Root Intrusion ☒ **Loose Brick** ☒ **Deteriorated**

chimney loose bricks

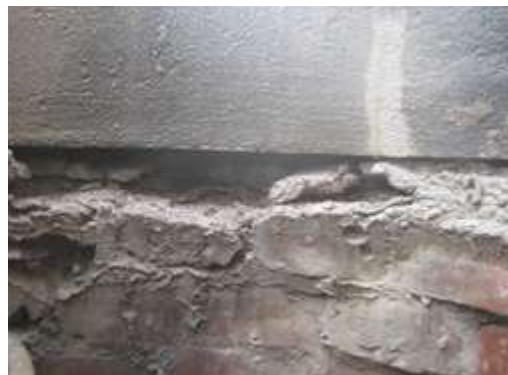
Defect 5

Infiltration: ☐ None ☒ **Joint** ☐ Cracks ☒ **Mortar** ☐ Roots ☐ Wall

chimney deteriorated with infiltration at frame joint and through mortar

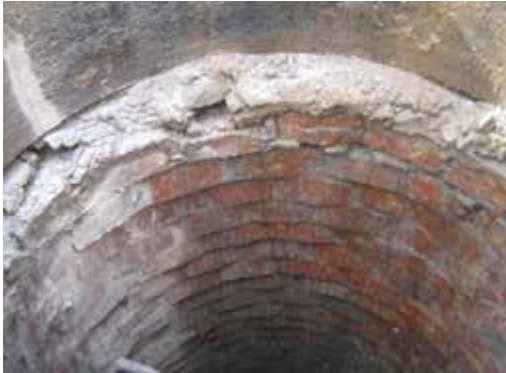
Defect 4

Frame Offset: **2.** (in.) Condition: ☒ Sound ☐ Cracked ☐ Leaks
75

frame offset 2.75

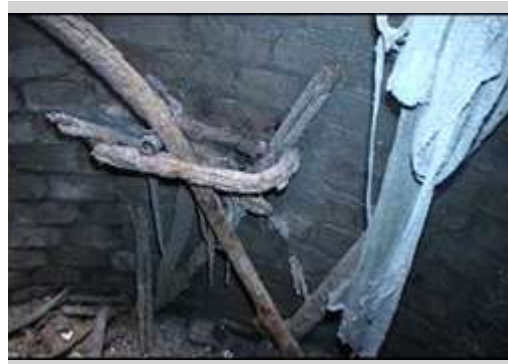
Defect 2

Steps Count: **8** Missing: **0** ☒ **Corroded**

step corroded, debris between bottom step and wall

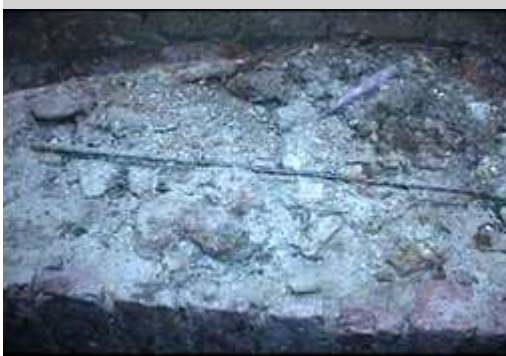
Defect 1

bench debris

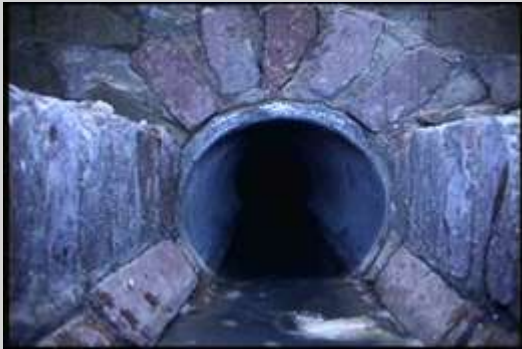
12 O'Clock Outflow

Pipe Height: **8.4** (in.) Rod and Bar (Angled)
Pipe Material: **Clay** ☐ Pipe Lined
Invert Depth: **10.58** (ft.) Flow Characteristics: **Fast**
Deposits: ☒ None ☐ Mud ☐ Sludge ☐ Debris ☐ Grease
Silt Depth: **0** (in.) Deposits Extent:
Infiltration: **None** Pipe Seal Cond: **Sound**

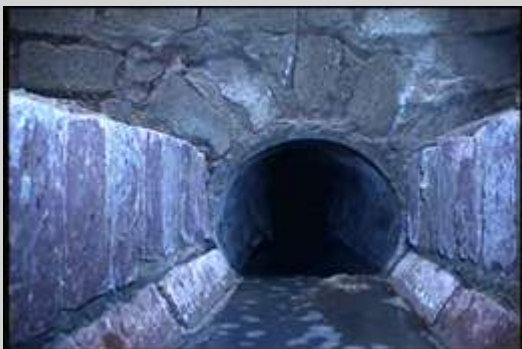
6 O'Clock Inflow

Pipe Height: **7.2** (in.) Rod and Bar (Angled)
Pipe Material: **Clay** ☐ Pipe Lined
Invert Depth: **10.66** (ft.) Flow Characteristics: **Fast**
Deposits: ☒ None ☐ Mud ☐ Sludge ☐ Debris ☐ Grease
Silt Depth: **0** (in.) Deposits Extent:
Infiltration: **None** Pipe Seal Cond: **Sound**
